**AIRBASE STRUCTURAL FACILITY
POSTATTACK RECOVERY - FOAL
EAGLE DEMONSTRATION**

**D.H. MERKLE, D.L. READ,
R.A. REID, J.M. UNDERWOOD,
N.F. KARASZEWSKI**

**APPLIED RESEARCH ASSOCIATES
P.O. BOX 40128
TYNDALL AFB FL 32403**

APRIL 1993

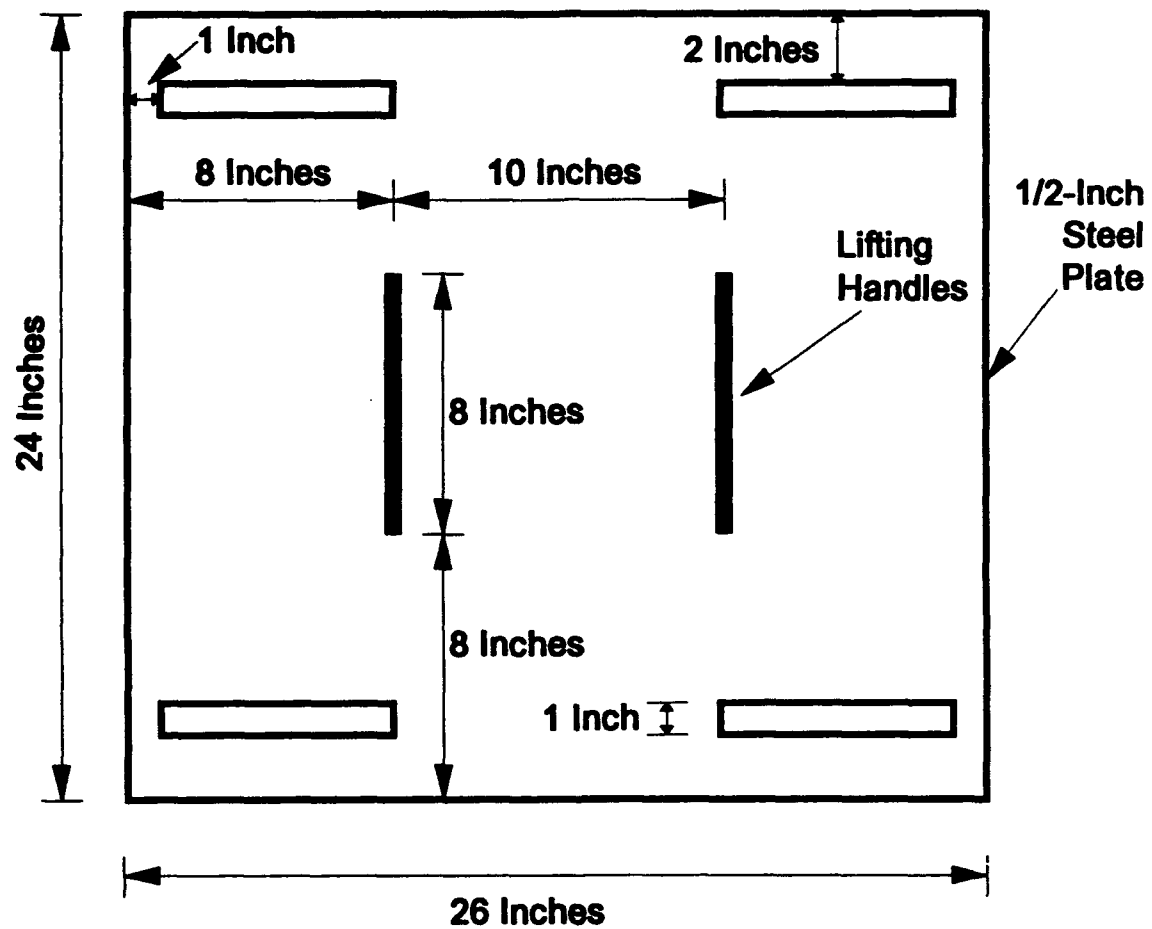
Figure 2. Detail Of Column Splint Plate.

When a reinforced concrete column is cracked, but still able to carry some load, a column splint can be used to repair, i.e., shore, the column. A column splint, shown in Figures 2 to 4, consists of two steel plates with slots in each corner, four threaded rods, and washers and nuts. The repair process, using such a splint, is briefly described below. A list of supplies, materials, and equipment required to carry out the repair during practice at Tyndall AFB, and during the FOAL EAGLE exercise, is listed in Table 2.

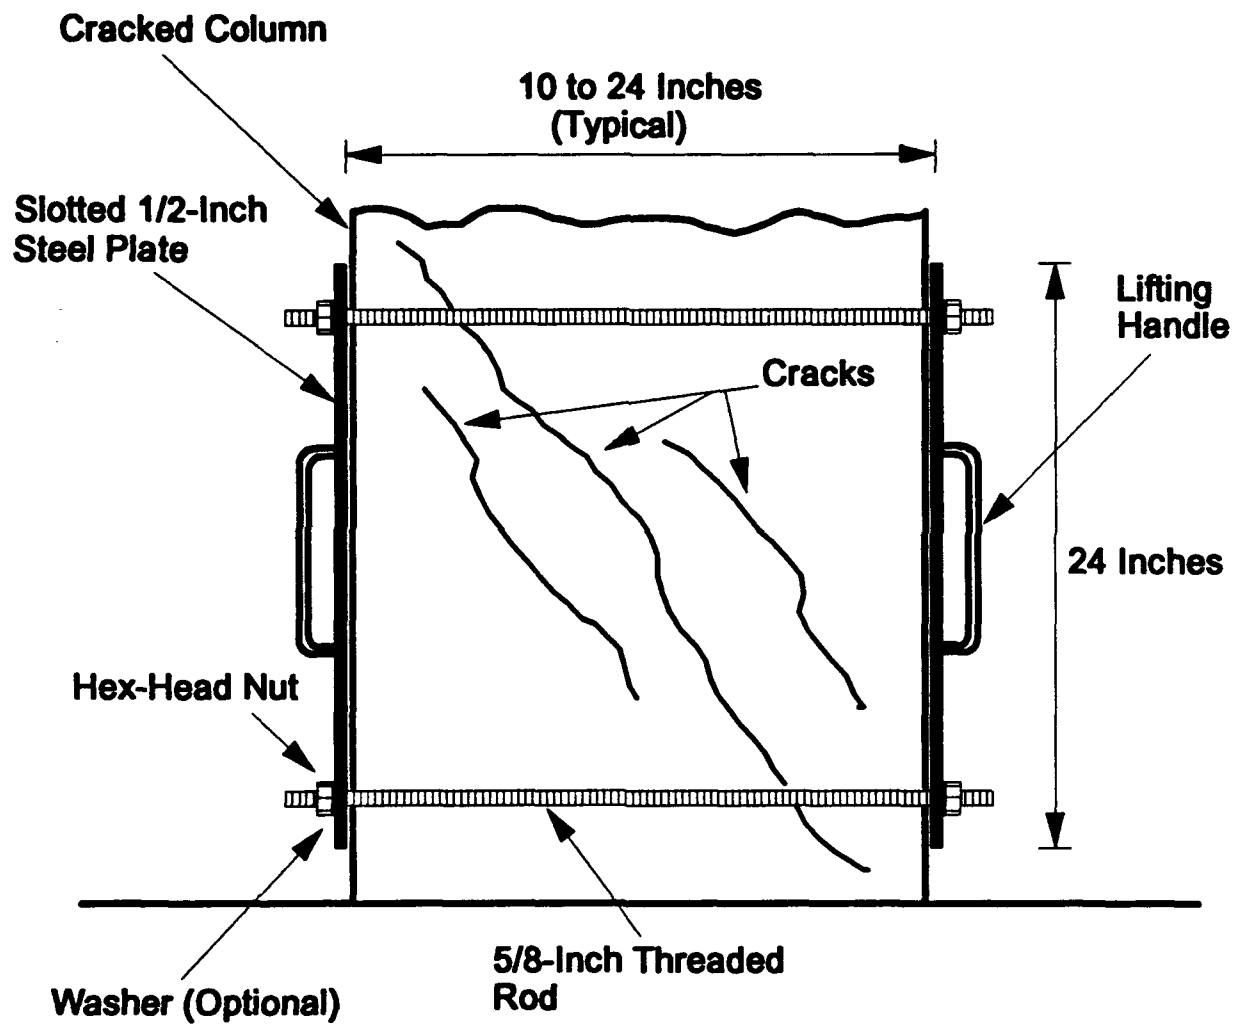
Figure 3. Side Elevation Of Column Splint.

Thread a nut with a washer on one end of each of the four threaded rods. Run a threaded rod through each slot in one plate, and through the corresponding slot in the opposite plate. Thread a second nut with a washer on the free end of each rod. Slide each rod in the slots until the rod contacts the side of the column, as shown in Figure 3. Hand tighten all eight nuts to snug the plates to the sides of the column.
